Mercedes W123 Sway Bar Link Replacement

The rear sway bar is connected to the hub assembly by what is called a sway bar link. Over the years the boots that protect the joints split, allowing in dirt and moisture, eventually ruining the joint. This can create a lot of noise from the rear.

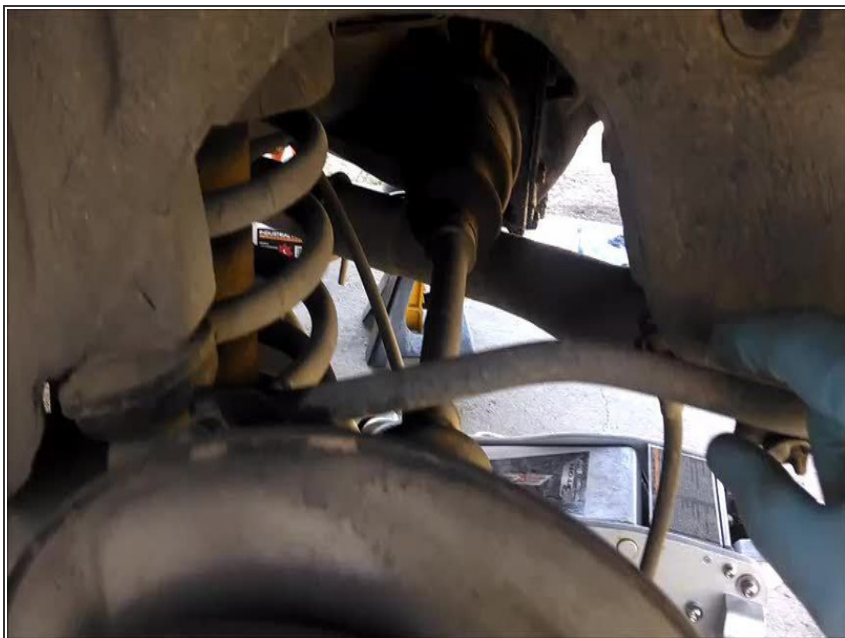
Step 4

- View this video to hear what a bad sway bar link sounds like when you move the sway bar around. If yours sounds like this is definitely time to replace it.

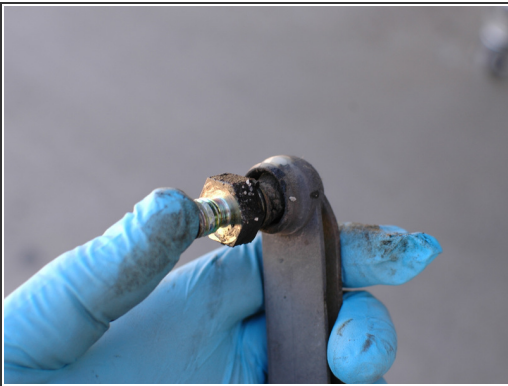
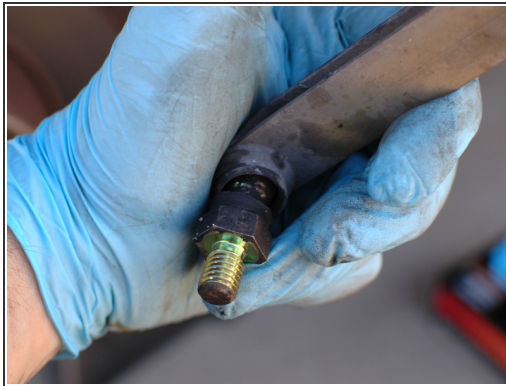
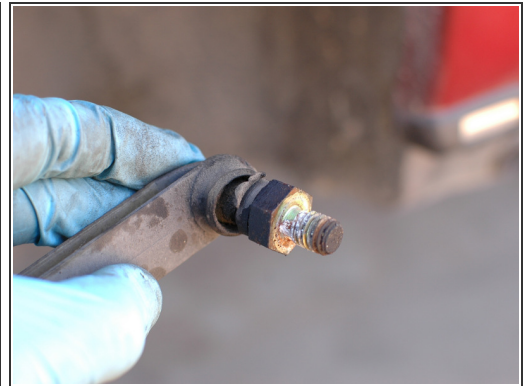
Step 6

- Pictured are example of the joints on the two sway bar links that were removed from this 1985 300D. Each one is split or even missing.
- You can see how this exposes the joint to moisture, dust, and road debris; this quickly ruins the joint.

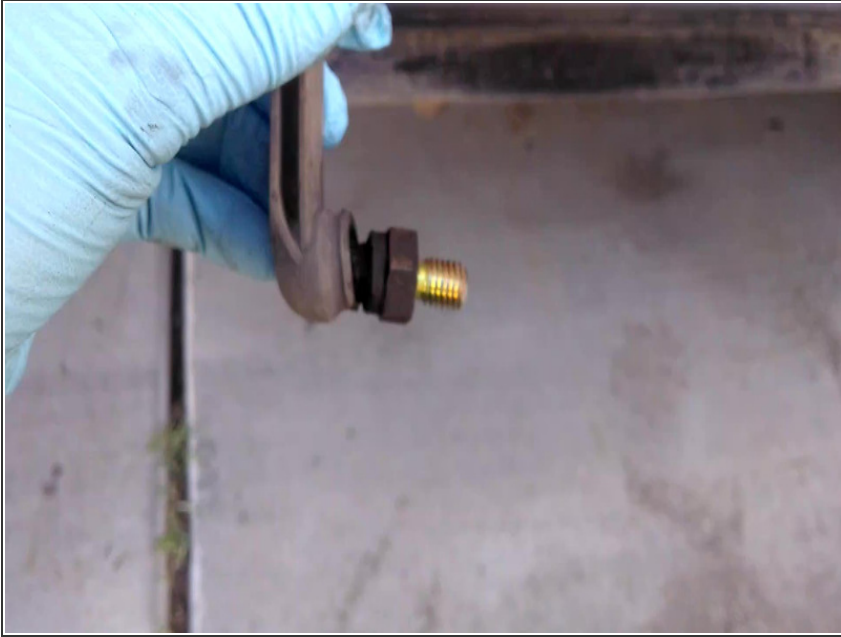
Step 7

- Watch this video to see how loose the bottom joint on this sway bar link was. It was half of the culprit for the clunking. The other side was just as bad.
